**Building Name:** Paul F. Titchener Hall

**Building Name:** 901 Front Street

## Brick Curbside and Concrete

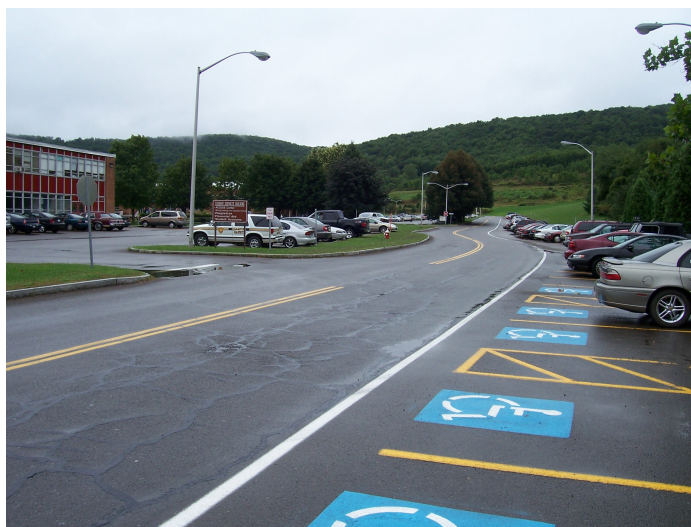
*View of North College Drive depicting the pavement in good condition*

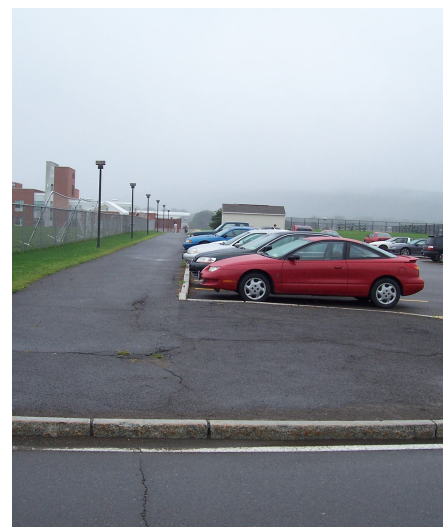
Some asphalt pedestrian walks have cracking and should be filled and sealed or considered for replacement. These include the walks from Campus Services to the south Student Services drive, from Campus Services to Decker Health Science Center and north of the Student Center connecting to the bus shelter. Also, cracking and weeds were noted in the walk from the Library to Front Street. Another area noted for potential replacement was the west pedestrian entry outside the Applied Technology Building as this appears as an old traffic turnaround. Water ponding was noted in the pavement at the connection of the Business and Mechanical Building.

*Asphalt walk from Campus Services to Decker*

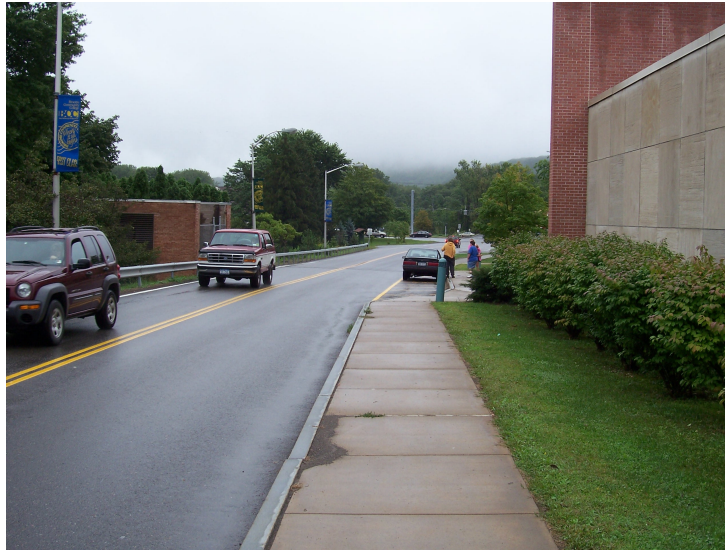
*View of North College Drive depicting granite curb and concrete walk on the North side of Titchener Hall*

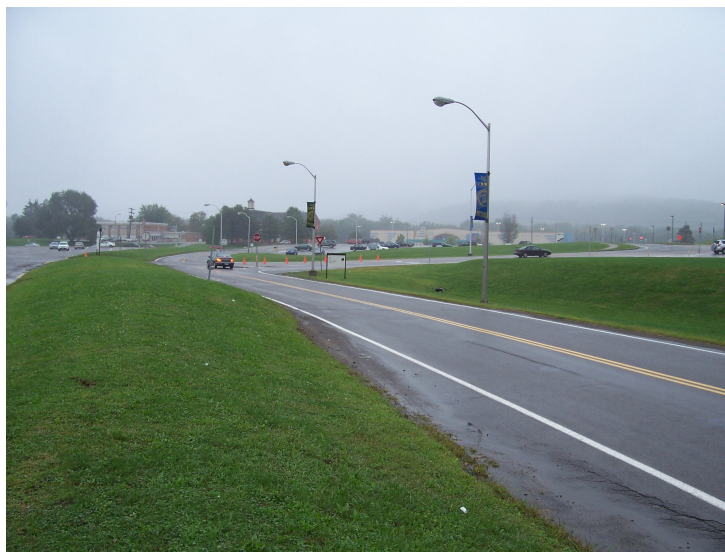
*View of South College Drive depicting no curb or walk along the road*

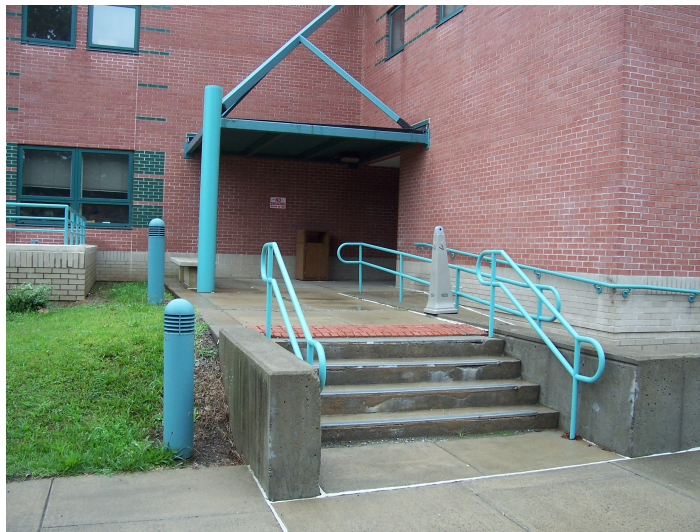
Once one ascends the primary elevation change from the primary student parking lot up to Mechanical Building, the campus is relatively flat in an east to west direction. Most stairs and ramps serve secondary and service building entries. Titchener, Science and Student Center buildings have staircase, ramp and handrail issues that were noted and should be corrected to prevent future stair deterioration and to address handrail compliance with ADA regulations.

*View of north entry to Titchener Hall depicting stairs and ramp*

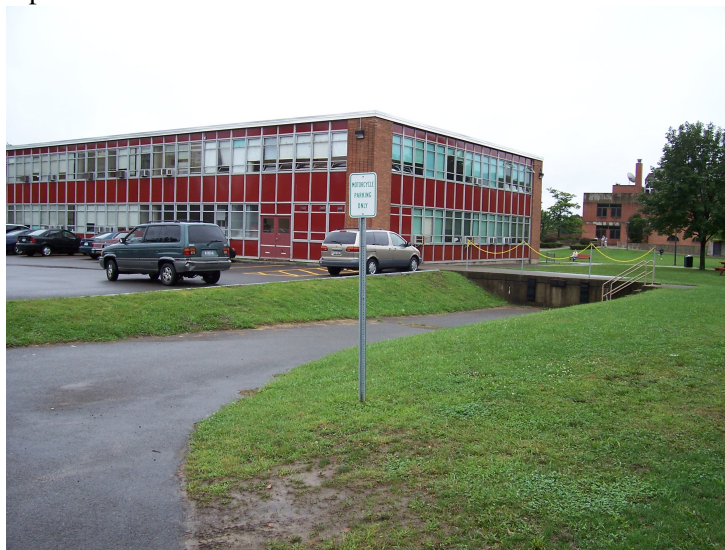
There were very few walls noted on campus. The concrete and brick planter walls between Applied Technology, Business and Mechanical Buildings were in good condition. The walls located on the east side of Business Building were fair with some precast wall coping needing repair. Lastly, there was a loading dock wall located west of Student Services Building that appears non-functional and should be removed or a code compliant temporary guardrail placed on top.

*View of northwest façade of Student Services depicting unused loading dock*

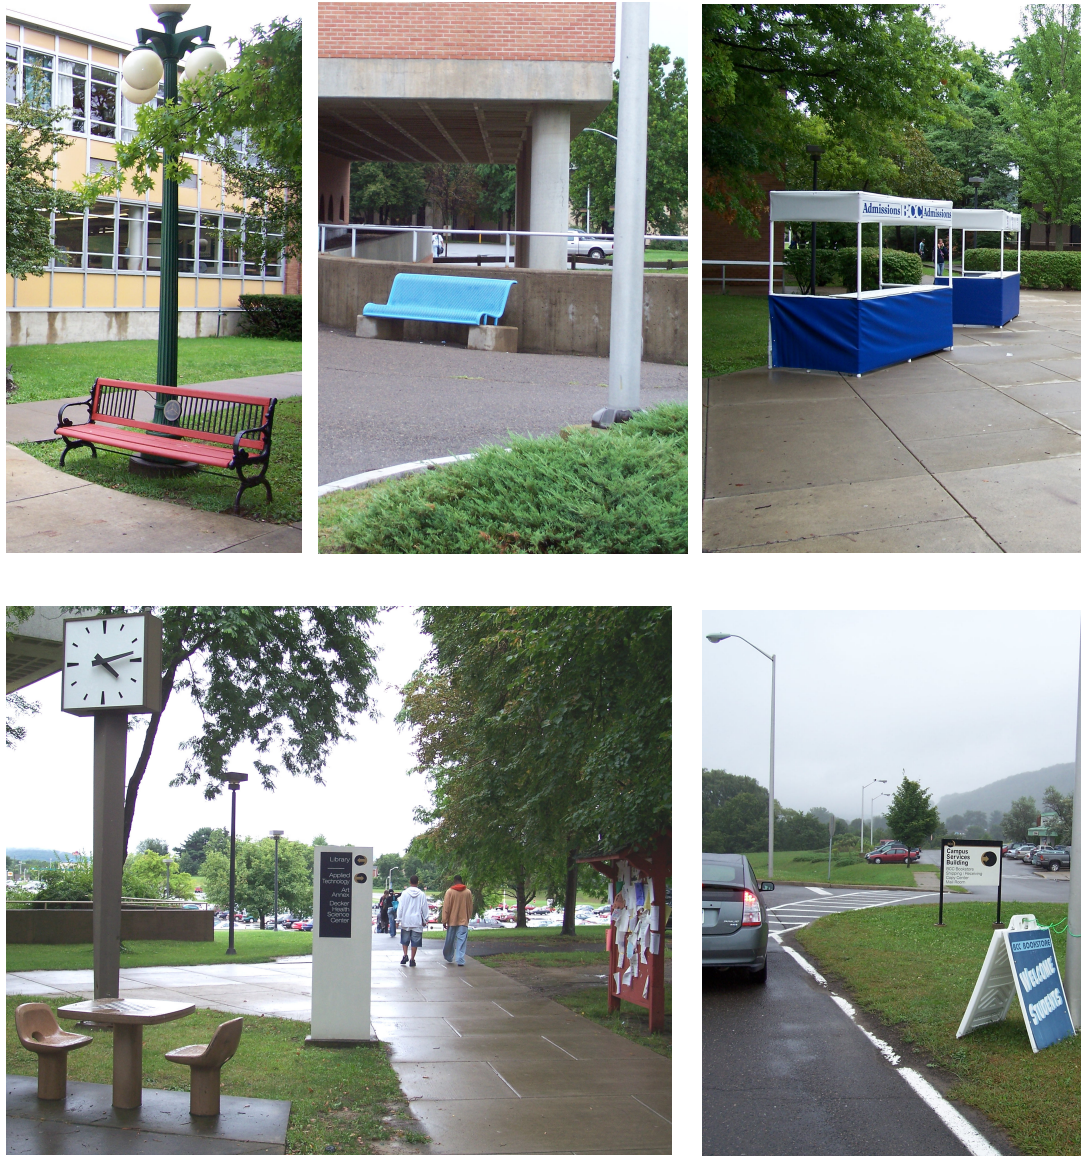
*Various styles and colors of site vocabulary and amenities found across the campus*

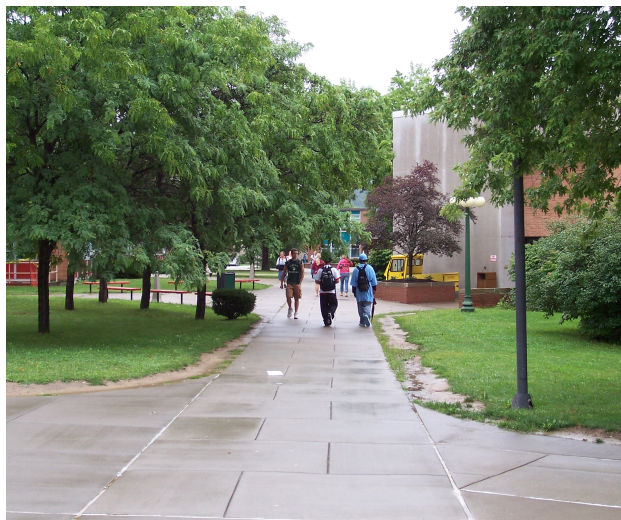
*View looking east toward Wales depicting low branching trees and worn walkway edges*

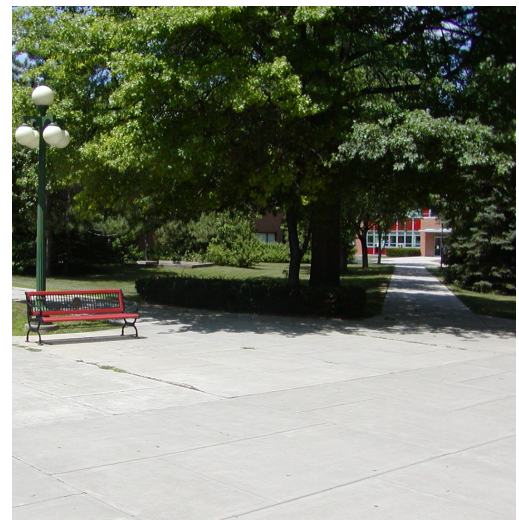
*View of Business and Wales quad limiting views from one side to the other*
